**CHRYSLER**  
CANADA LTD.

# SERVICE • BULLETIN

BULLETIN NUMBER 2077

SUBJECT: ELECTRICAL  
SUJET: CHRYSLER ELECTRONIC  
IGNITION SYSTEM

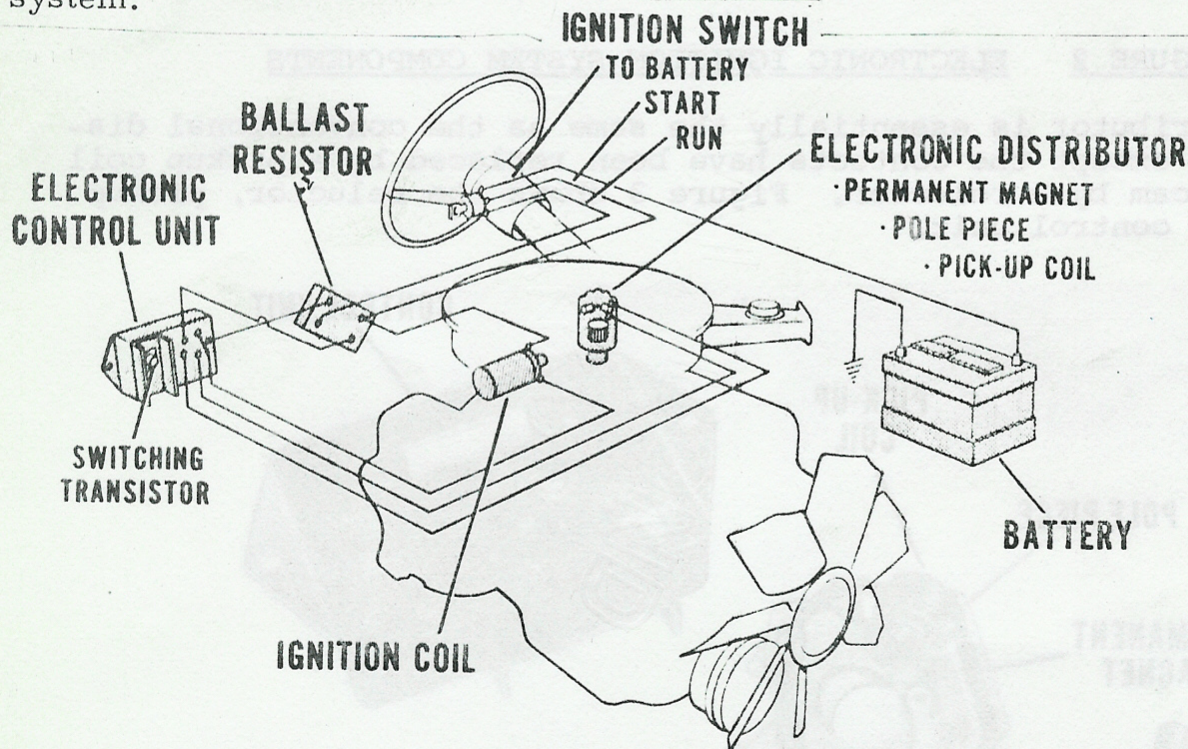
**FIGURE 1 CHRYSLER ELECTRONIC IGNITION SYSTEM**

Engines with the Electronic Ignition System can be easily identified. The distributor will have a double primary wire. The ballast resistor will be of dual type and a control unit will be mounted on either the dash or fender shield. Figure 1 shows the Chrysler system.

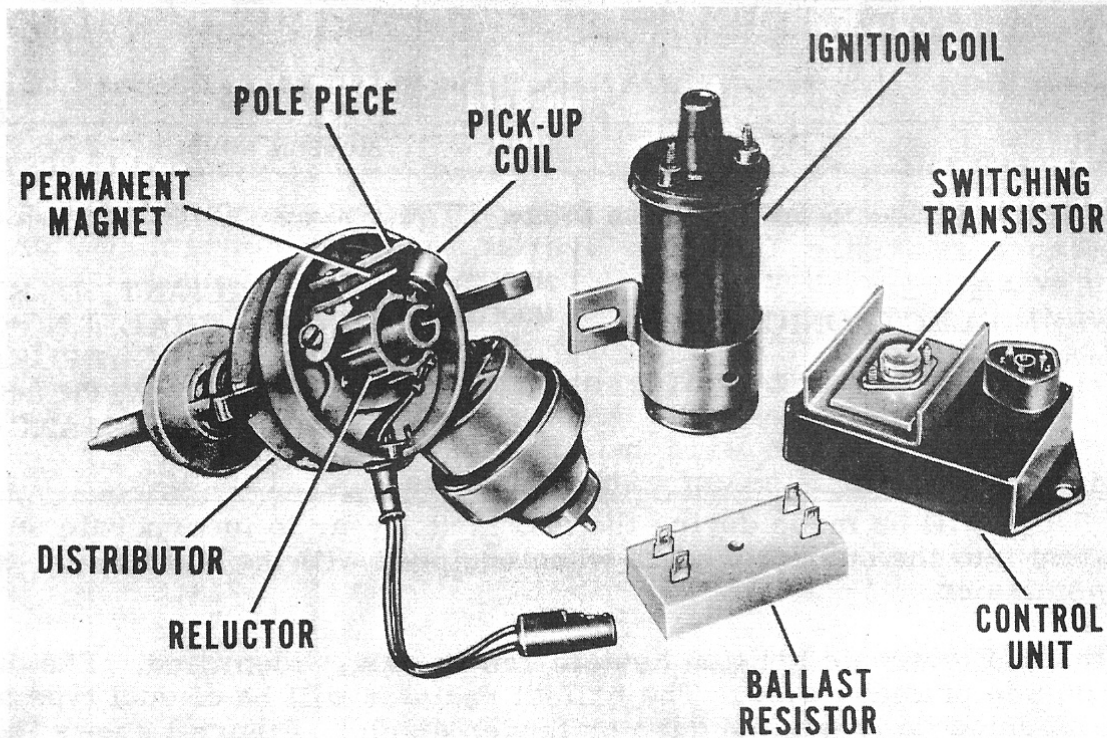
FIGURE 2 ELECTRONIC IGNITION SYSTEM COMPONENTS

The Chrysler Electronic Ignition System is composed of a magnetic distributor, an electronic control unit, a wiring harness, a production coil and a dual ballast resistor. See Figure 2.

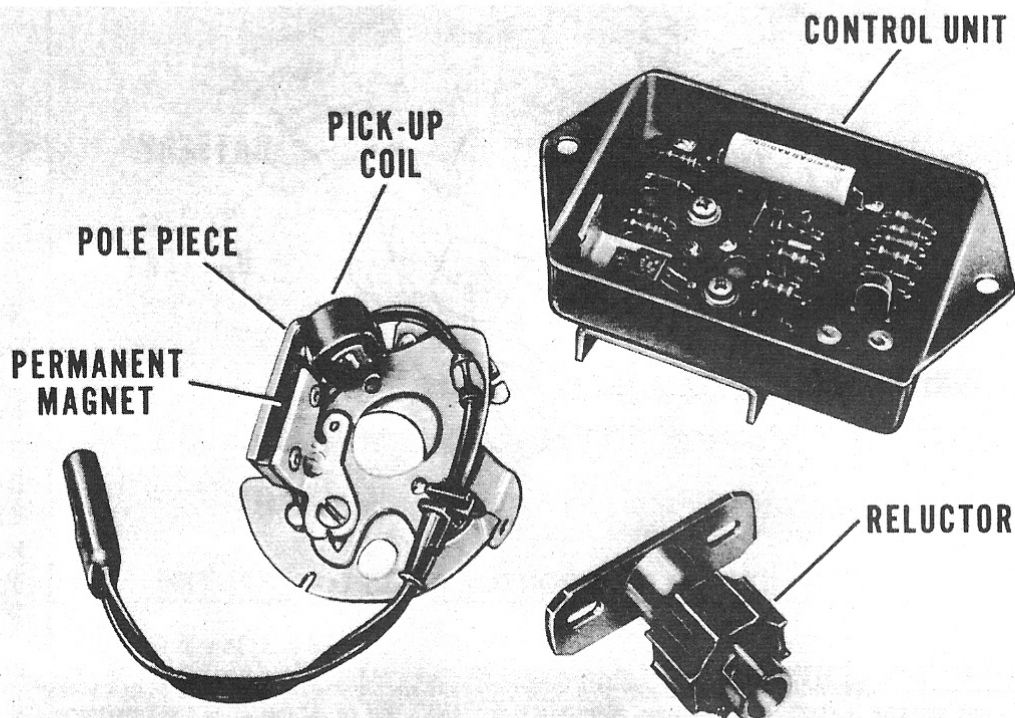
FIGURE 3 MAGNETIC PICKUP COMPONENT AND CONTROL UNIT

The distributor is essentially the same as the conventional distributor except the contacts have been replaced by a pickup coil and the cam by a reductor. Figure 3 shows the reductor, pickup coil and control unit.
